# Can we trust guided surgery in tight spaces?

Bruno Leitão de Almeida, DDS, MSc, PhD

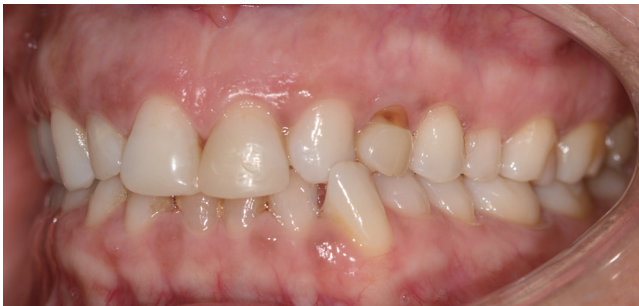
Fig 1. Intra-oral clinical appearance at initial stage

A healthy 45-year-old female presented with complaints of tooth movement and esthetic impairment of the upper left cuspid position. Clinical and radiographic examination revealed a deciduous cuspid in the arch. The root length and resorption explained the tooth mobility, while abfraction of the deciduous crown, a high smile-line, crossbite, and short clinical crown were all responsible for the esthetic impairment (Figs. 1,2).

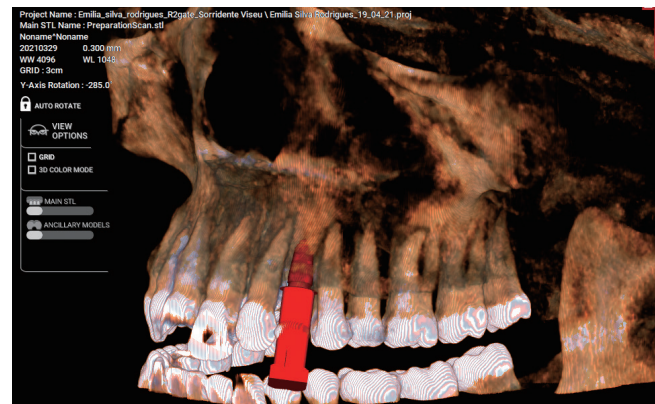
Fig 4. R2GATE planning, 3D rendering, Buccal view

While initial correction of the crossbite was advised, the patient refused and only wanted to address the main complaint. Thus, immediate dental implant placement after extraction with a direct provisional was planned. The CT scan and silicone tray impressions (no intraoral scan was available) were sent to the R2GATE® Center (Corus, Porto, Portugal). An AnyRidge implant (3.5mm diameter/8.5mm length) was selected based on the case planning using R2GATE® software (Figs. 4, 5), and after clinical validation a tooth-supported sleeveless stent was designed for the implant placement (Figs. 6, 7).

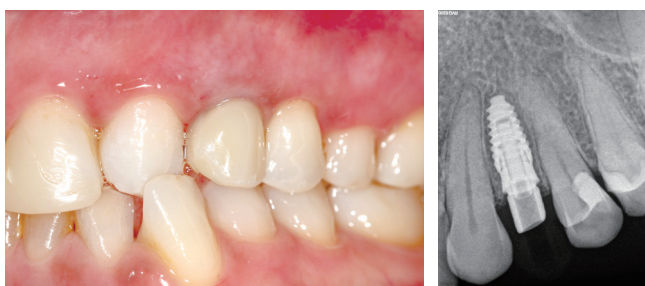
Fig 9. Clinical buccal view of the provisional in place and radiographic check of positioning

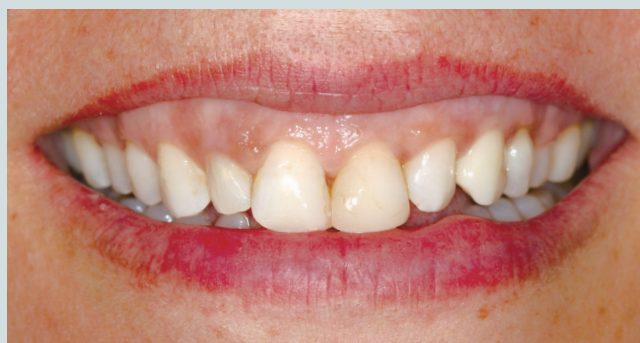
Fig 11. Extra-oral view of final result in wide smile. Check how high the smile line is.

manufacturer's suggested protocol, and the total surgery time was 5 minutes. Intra-oral x-rays were taken to check the implant position, and a clinical view of the axis upon placement is shown in Fig 8. The torque and ISQ values allowed for immediate loading and a direct restoration was performed chair-side using a provisional cylinder (1.5mm) and composite. The occlusion was addressed to avoid any contact due to intercuspitation or lateral movements during the provisional phase (Fig 9). After 3 months, the provisional was removed and final tray-impressions were performed for the final crown (Zirconia, Ti Base 1.5mm) (Fig 10, Fig11). The 2-year clinical and radiographic follow-up are presented in Fig 11 & 12, where the hard and soft tissue stability demonstrate a successful outcome.

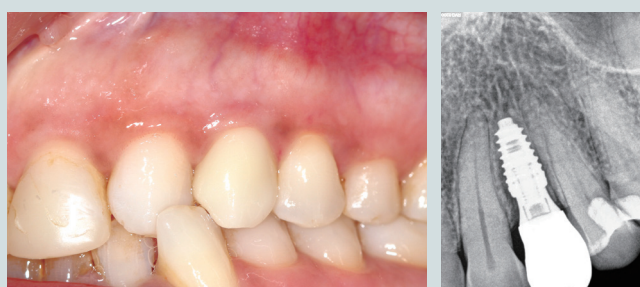
Fig 12. 2-years follow-up on clinical and radiographic stability
