## Immediate post-extraction insertion of implant & immediate loading

Prof. Giuseppe Luongo

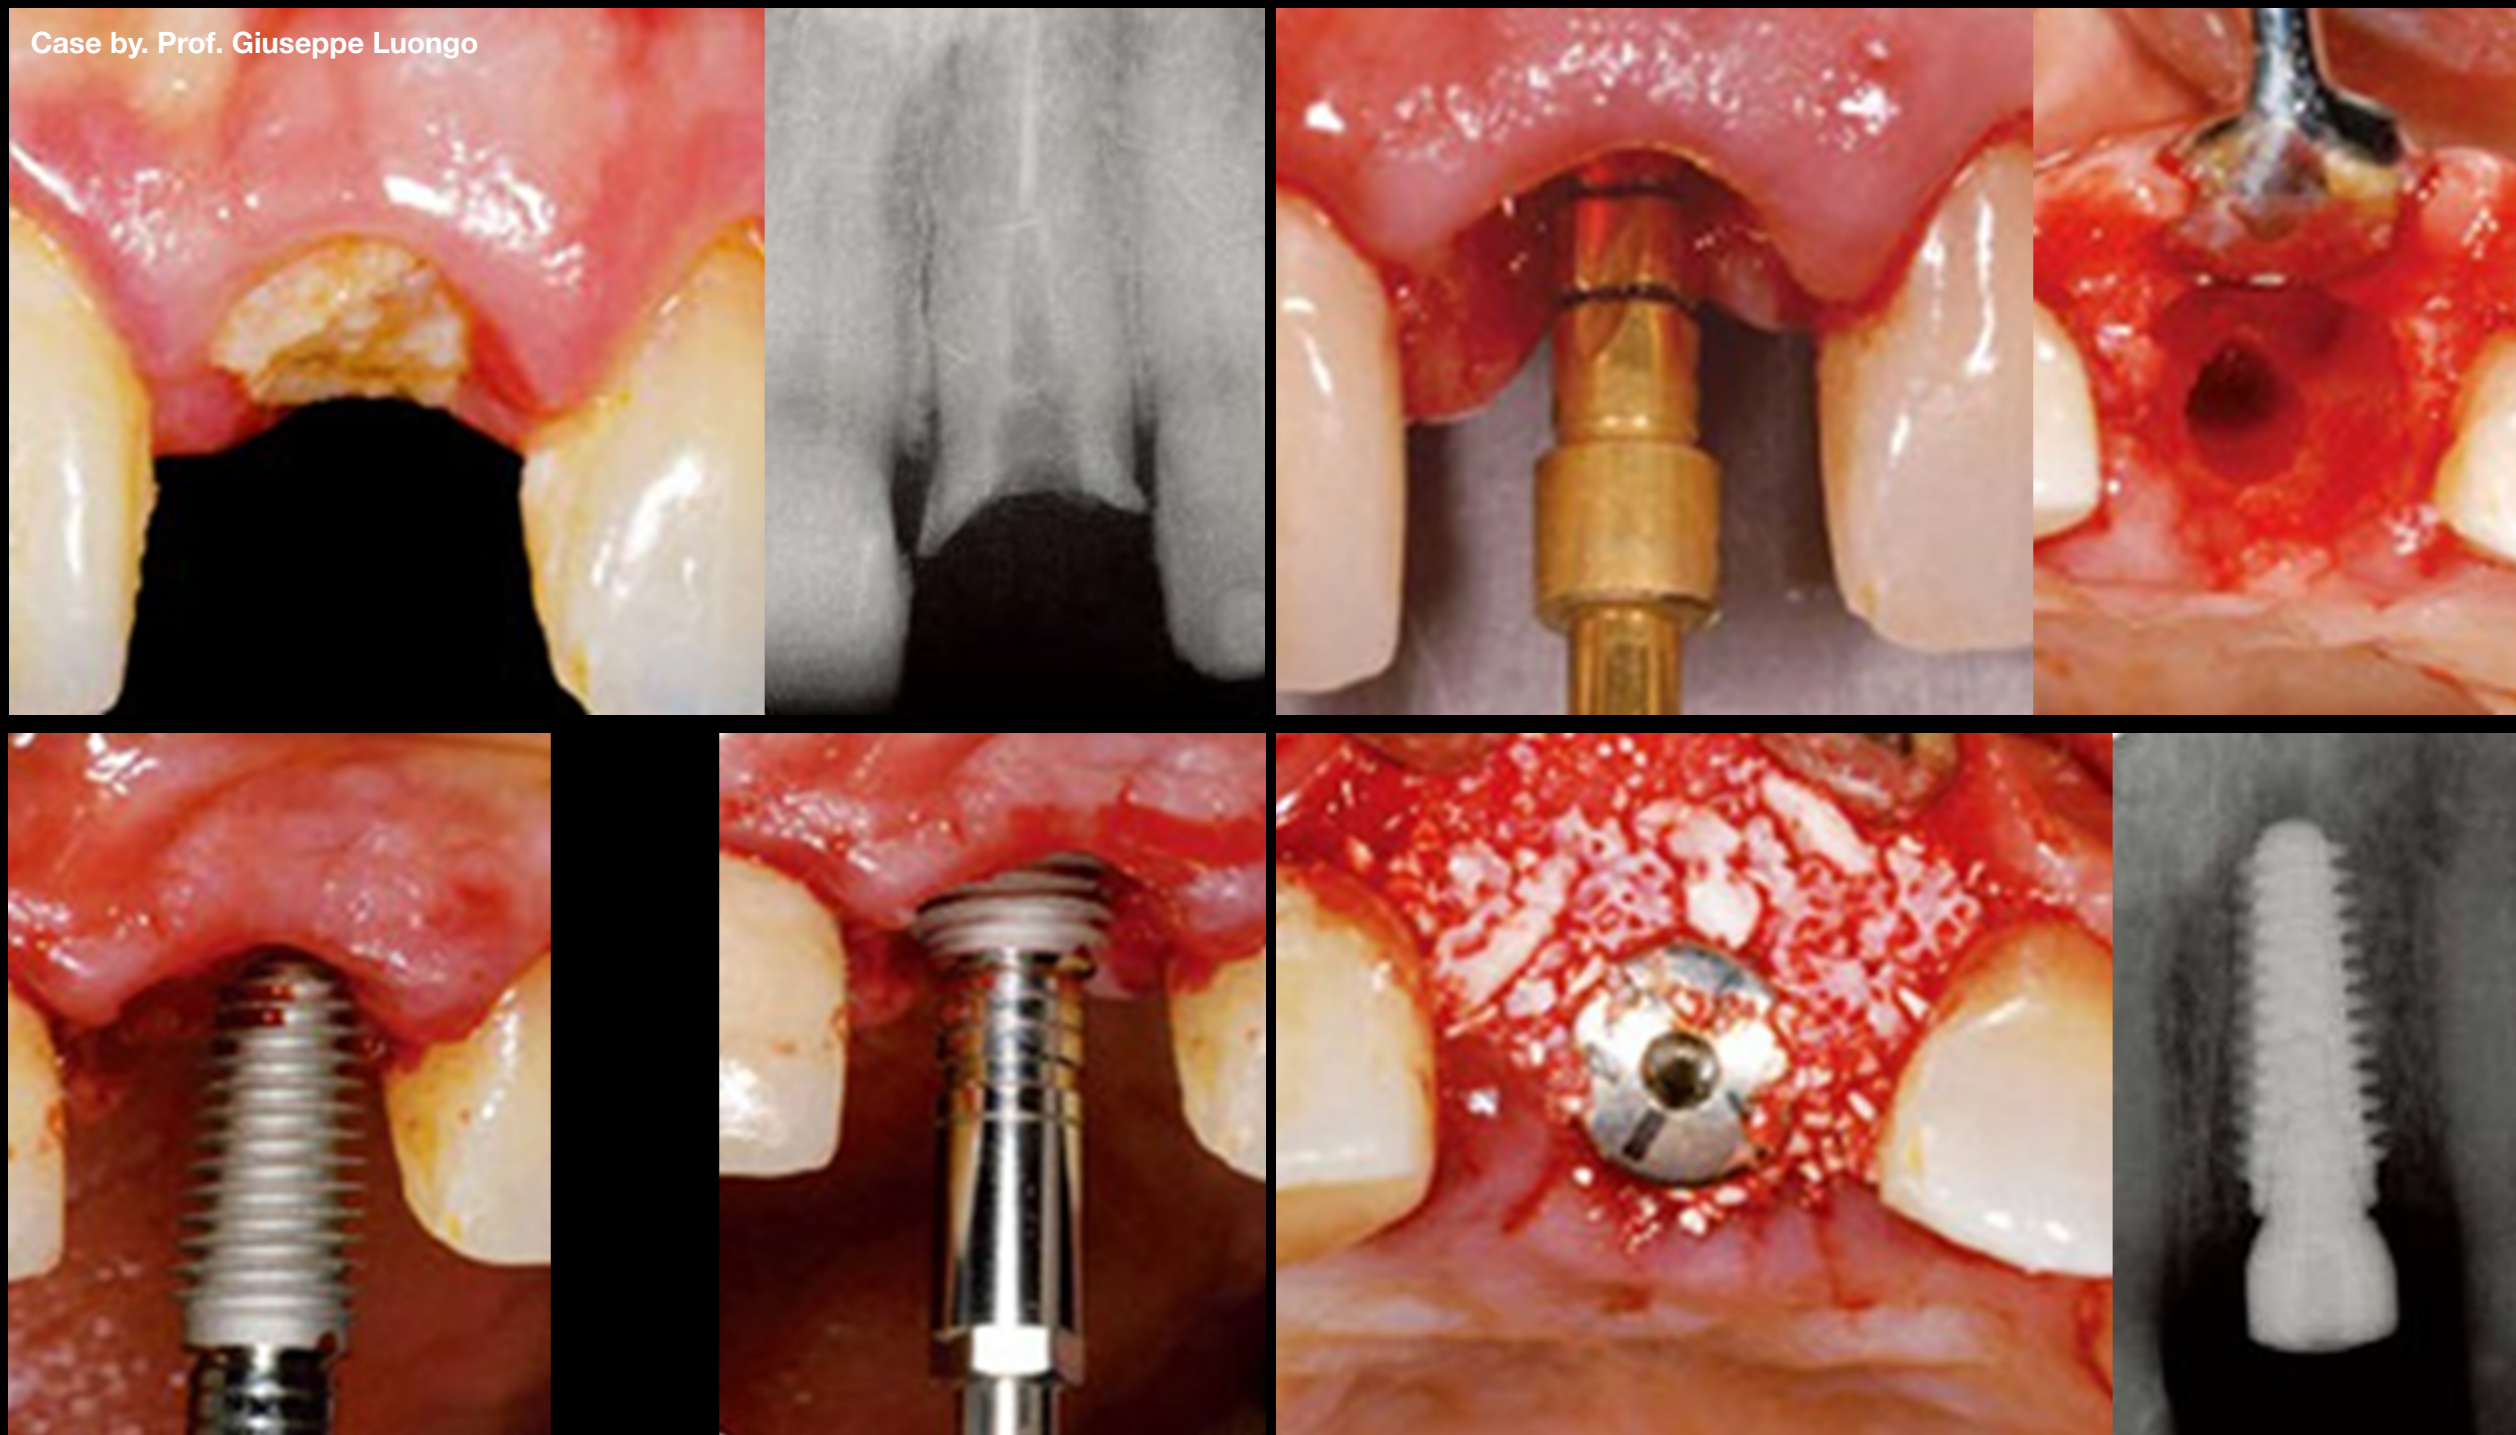
**Fracture of #21 tooth / Good stability of hard & soft tissues indicates immediate post-extraction insertion of implant & immediate loading**  
**To protect esthetic outcome, implant site was prepared via slightly palatal alveolar access**  
**4.5×11mm AnyRidge was placed in prepared site**  
**Biomaterial was added to vestibular aspect to improve stability of esthetic**

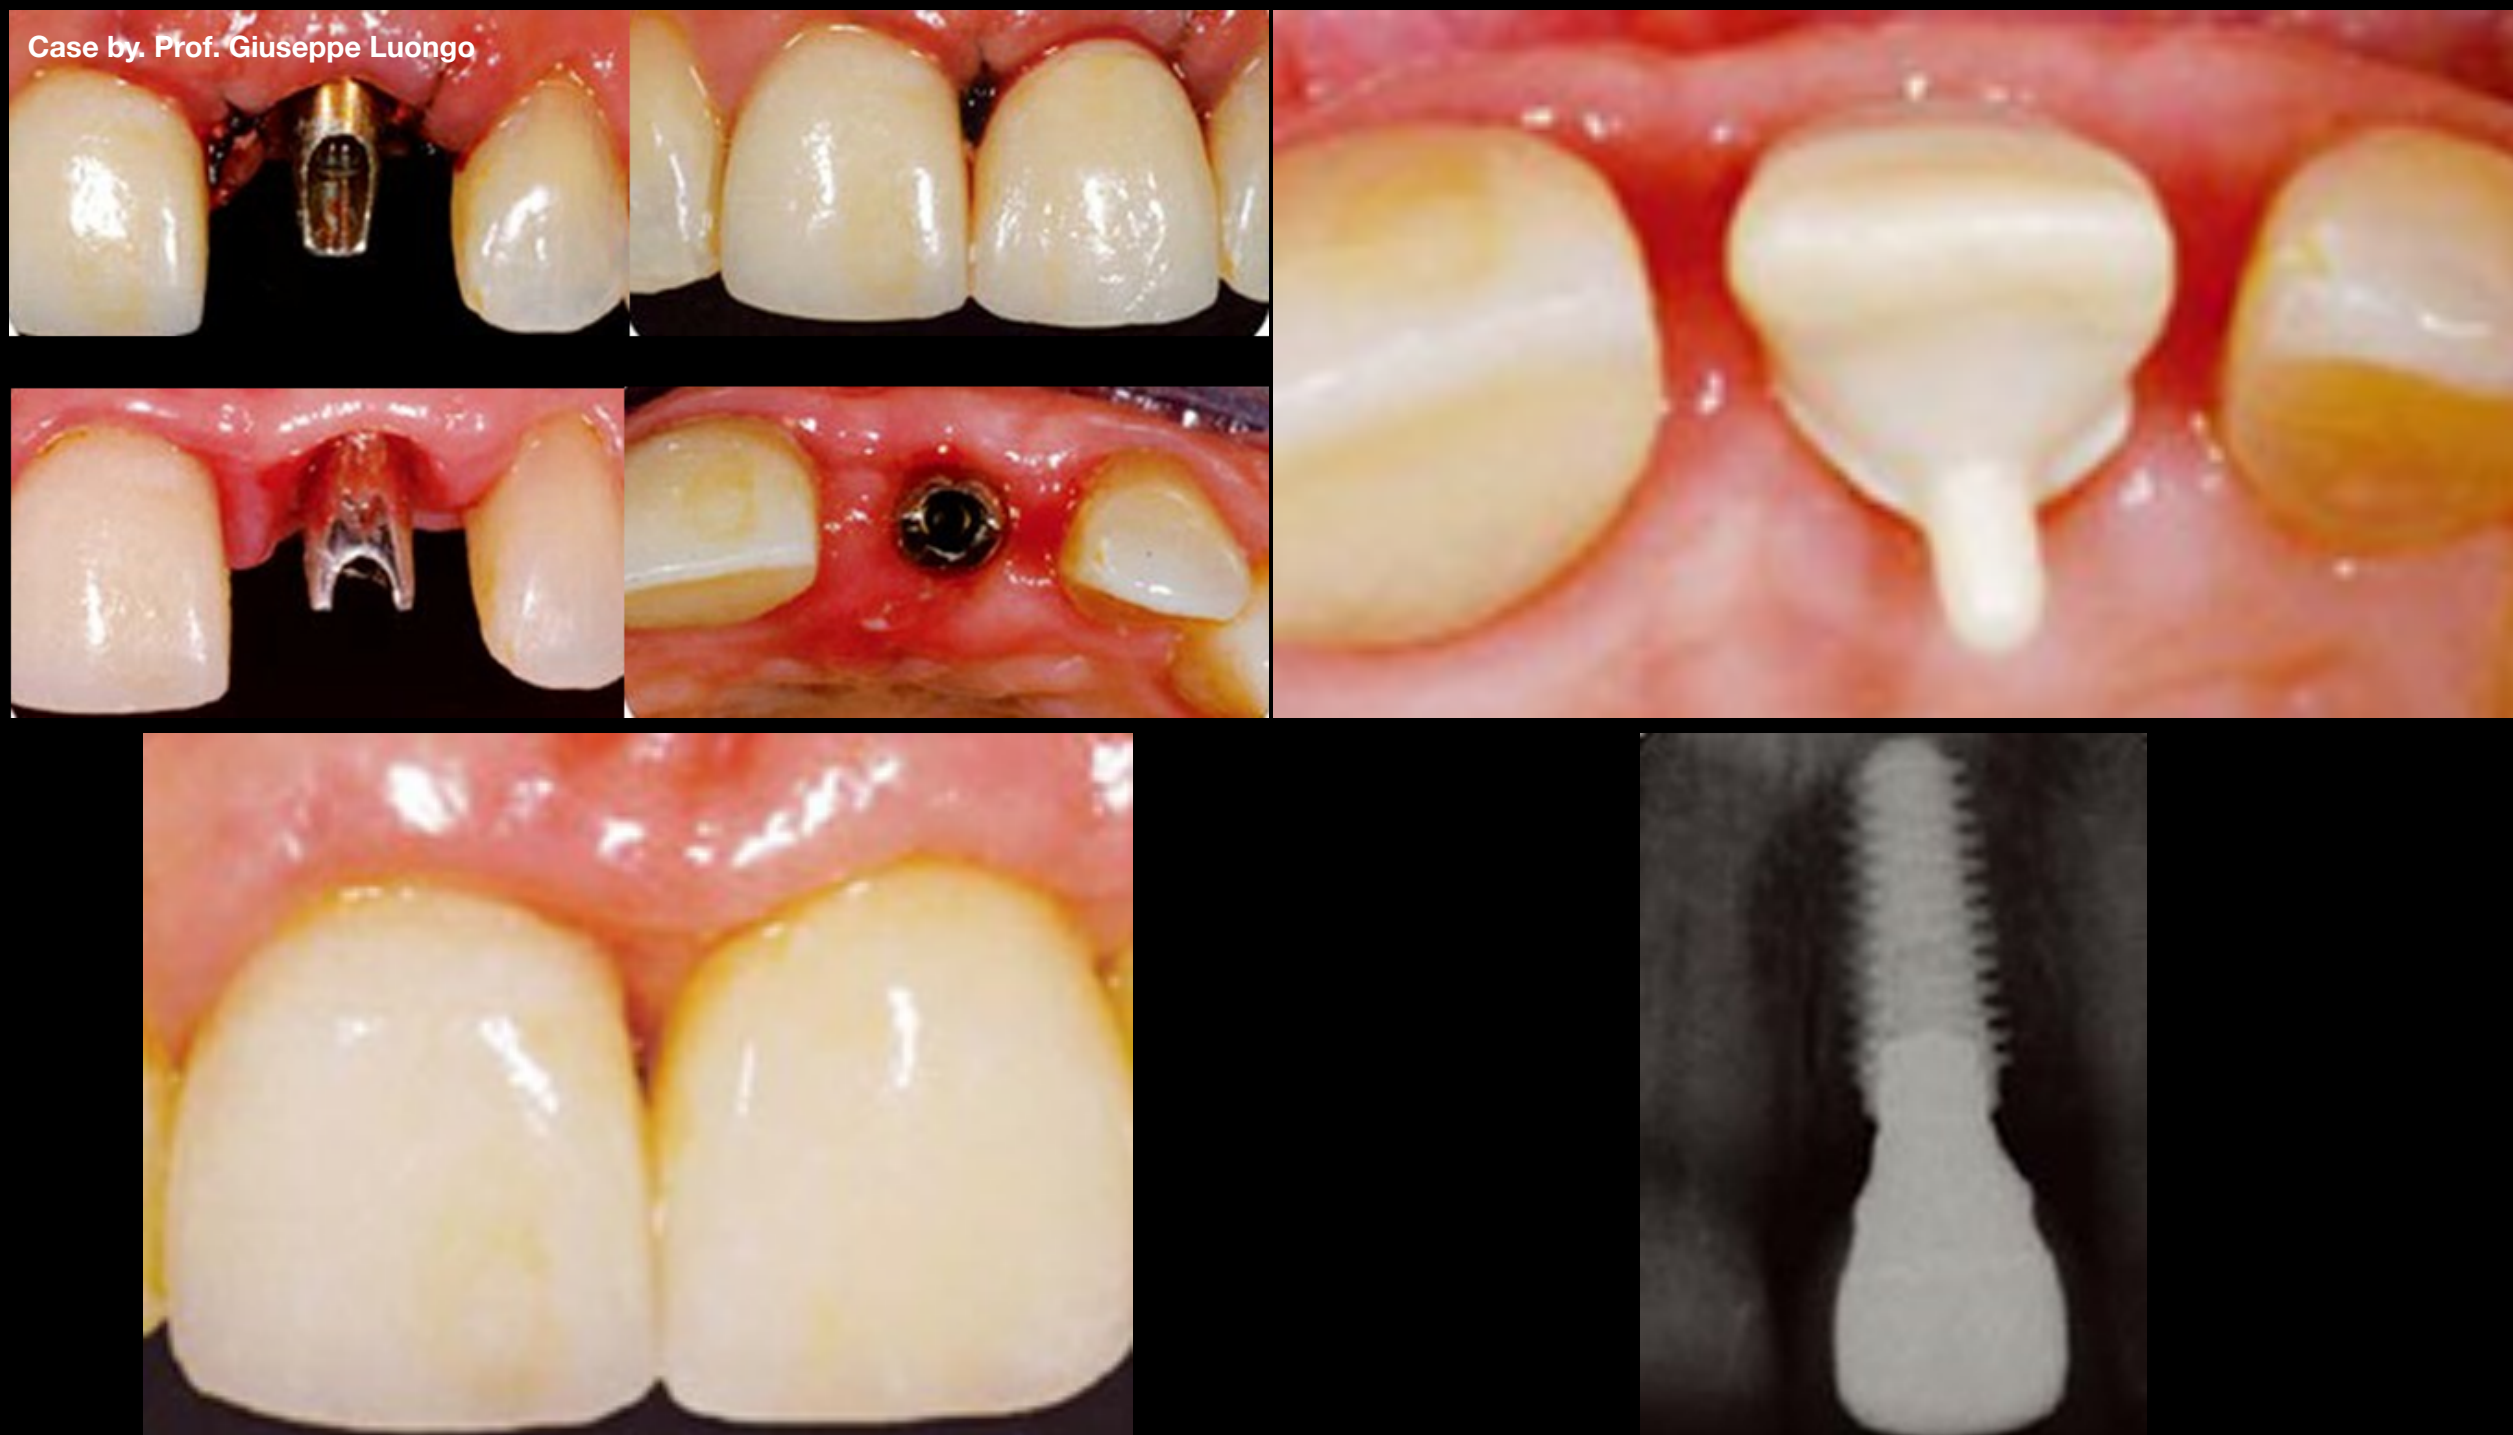
**Temporary crown was placed immediately / After 12 wks, tissue was ready to proceed with final abutment & crown**  
**Implant position harmonized with surrounding tissue**  
**Photo of final crown at time of placement**  
**Intraoral scan of final crown at time of placement**

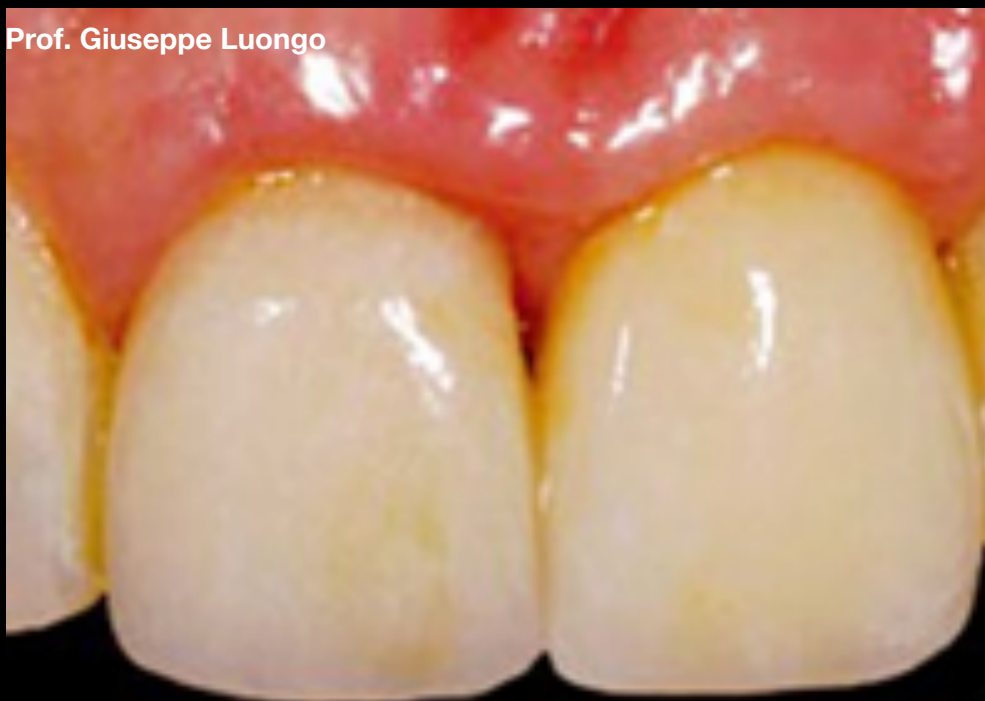
Photo of final crown at 1-yr follow-up

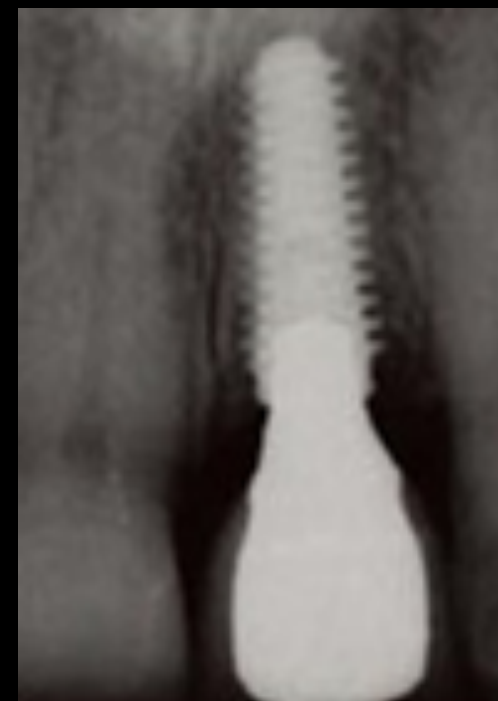
Intraoral scan of final crown at 1-yr follow-up

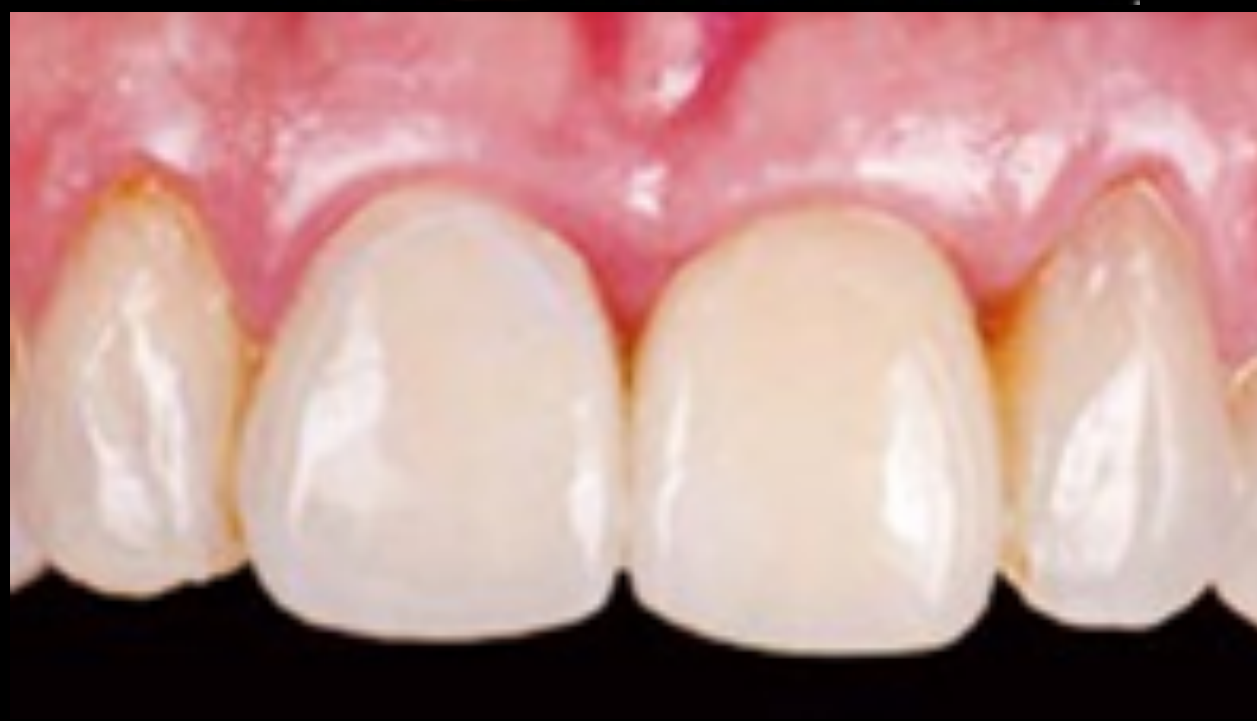
Photo of final crown at 5-yr follow-up

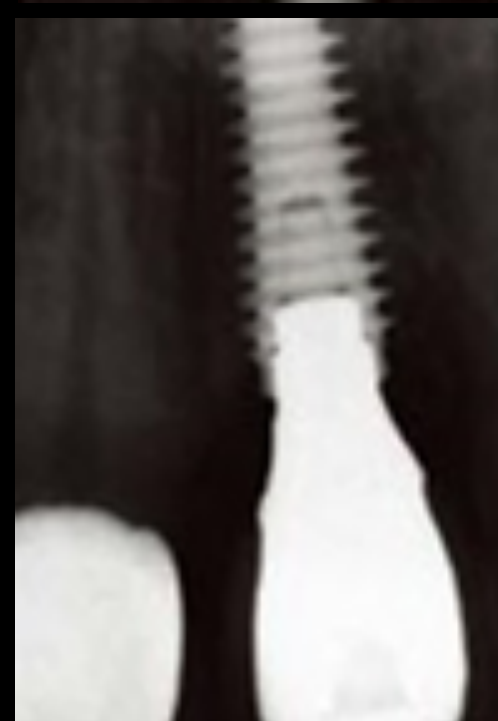
Intraoral scan of final crown at 5-yr follow-up
